IN THE UNITED STATES DISTRICT COURT
FOR THE DISTRICT OF COLORADO

Civil Action No. 05-cv-645-MSK-BNB

**DEFENDANT GENERAL MOTORS CORPORATION'S
MOTION FOR SUMMARY JUDGMENT**

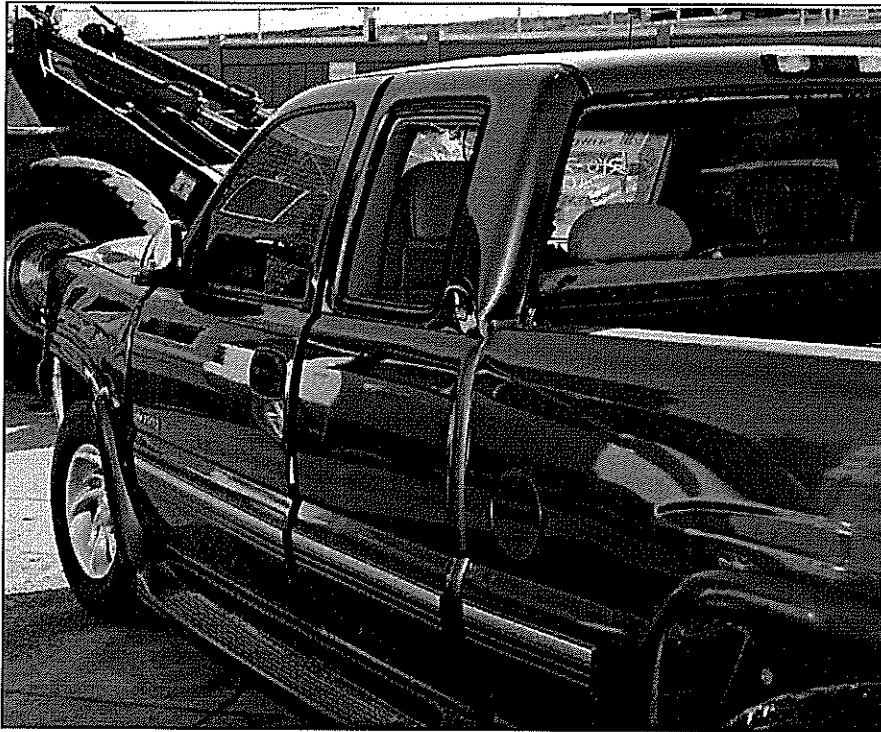
Photograph #1

The subject accident took place May 21, 2003 on I-70 near Burlington, Colorado. It was a single vehicle collision involving a 2000 Chevrolet 1500 Silverado driven by Gorgonia Diaz. Other occupants included Jose Alfaro sitting in the right front passenger position and Jacqueline Diaz, 23 months, in a child restraint system in the rear center position of the extended cab. According to the Colorado Traffic Accident Report, the vehicle deviated to the left from its eastbound lane of I-70 and onto the center median. It then struck a raised median crossover, became airborne and impacted the ground with the front and undercarriage of the vehicle.

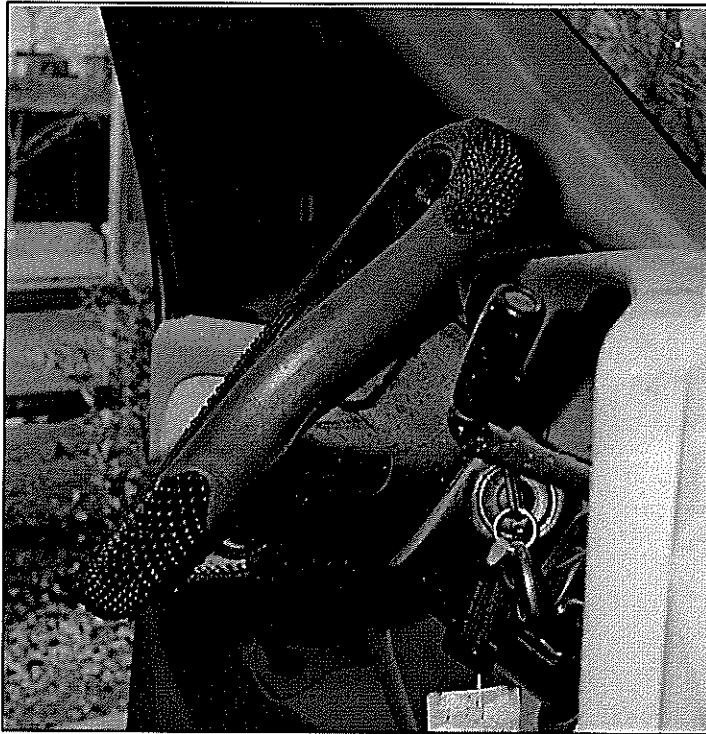
Photograph #2

The interior of the vehicle revealed evidence of severe occupant impacts. The steering wheel was deformed forward at the upper part of the wheel rim consistent with driver impact. See photograph #2. The windshield on the driver side sustained three fracture patterns consistent with direct impact to the windshield. See photograph #3.

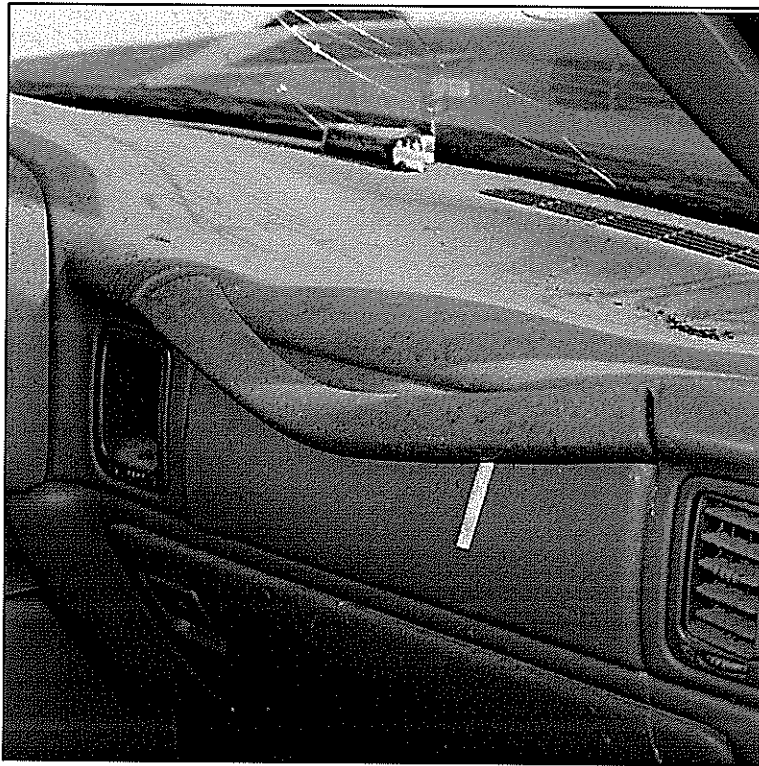
Photograph #4

On the right side of the vehicle, the passenger grab bar located just above the passenger airbag module cover was severely bent forward and down. See photograph #4. The dashboard exhibited marks consistent with impact by Mr. Alfaro's teeth.

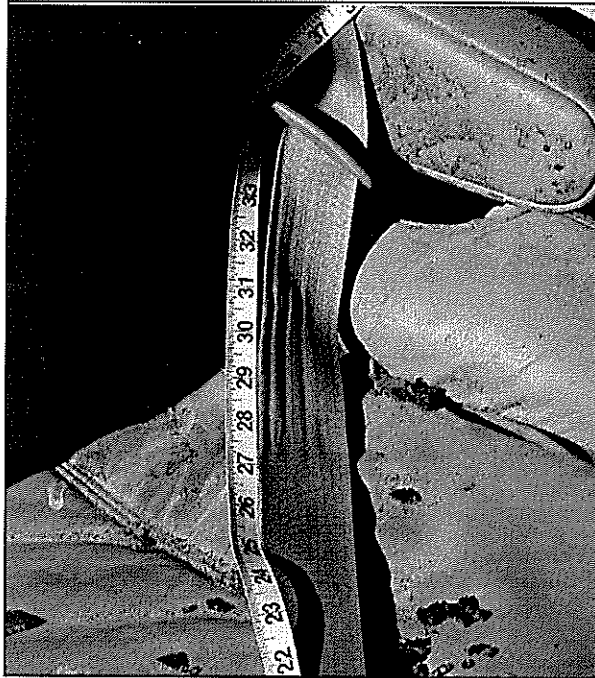
Photograph #5

The right front passenger seatbelt webbing exhibited wavy, parallel passthrough lines in the area where it contacts the latchplate. See photograph #5. This evidence is consistent with occupant loading of the seatbelt. As mentioned earlier, Mr. Alfaro had a residual injury pattern on his right shoulder consistent with shoulder belt loading.
